Unconventional Solutions, Inc.
Experts in Repair and Protective Coatings
MI 248.735.7000 | OH 937.704.4220
www.USIgroups.com

Project: 54" Composite Pipe Wrap

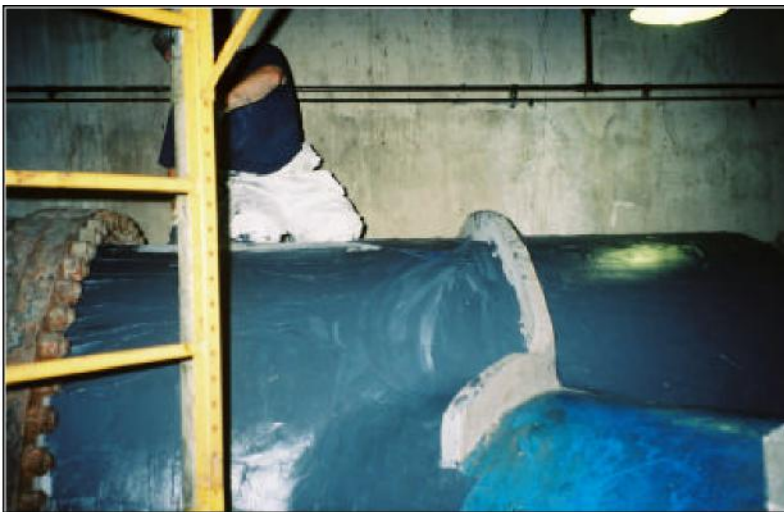
This WWTP's main in flow pipe - carrying 350 million GPD - had ruptured in several small areas.

We applied **USI Ceramic Rebuild** at 120 mils over the prepared pipe surfaces. Nylon mesh was imbedded in the wet **USI Ceramic Rebuild**. A second coat of **USI Ceramic Rebuild** was applied at 60 mils over the meshed surfaces.

A final topcoat of **USI Ceramic Lining FG** applied at 40 mils. The finished system was at 240+ mils.
