Project: 54" Composite Pipe Wrap

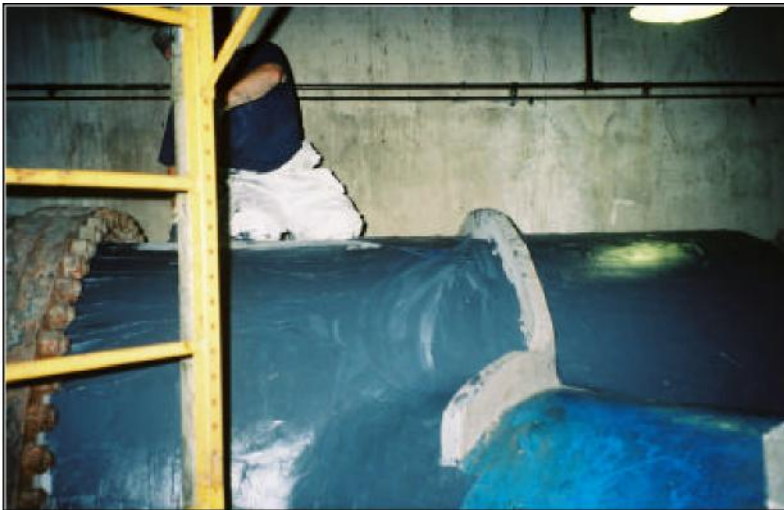
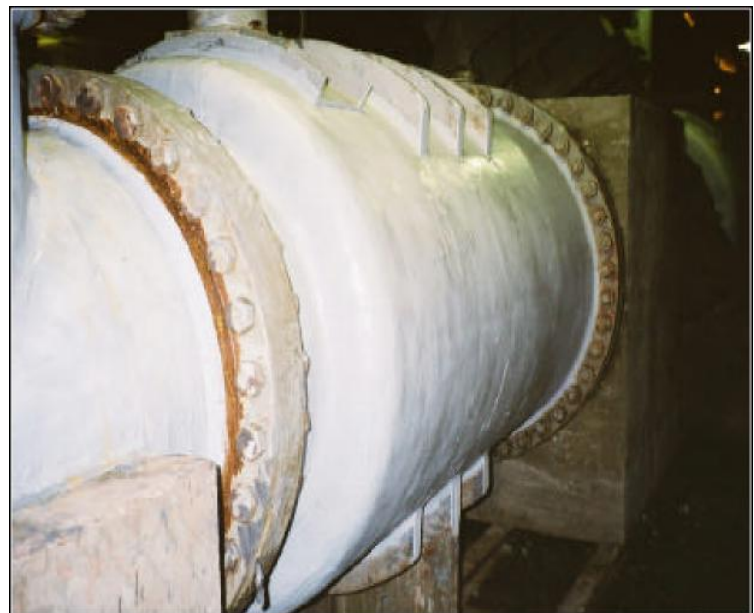
This WWTP's main in flow pipe - carrying 350 million GPD - had ruptured in several small areas.

We applied **USI Ceramic Rebuild** at 120 mils over the prepared pipe surfaces. Nylon mesh was imbedded in the wet **USI Ceramic Rebuild**. A second coat of **USI Ceramic Rebuild** was applied at 60 mils over the meshed surfaces.

A final topcoat of **USI Ceramic Lining FG** applied at 40 mils. The finished system was at 240+ mils.
