Fan Impeller Refurbishment

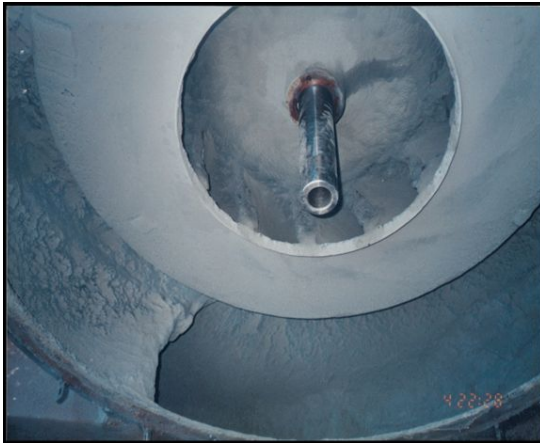
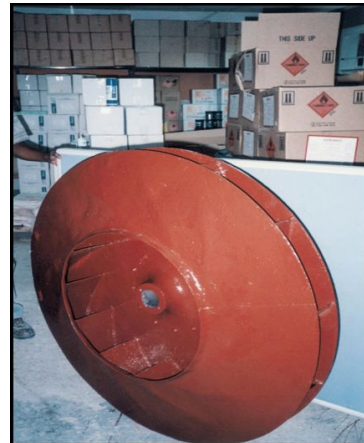
The carbon steel impeller of this dust extraction fan had been subjected to heavy wear as a result of the very aggressive operating conditions. The fan is used to extract gas laden with iron dust.

All loose material was scraped away. The surface of the impeller was degreased using the USI Cleaner and blast cleaned to a minimum industry standard of NACE 2.

Our multi-purpose RESIMAC 201 Ceramic Repair Paste was used to rebuild the deeply pitted areas prior to the application of two coats of RESIMETAL 202 Ceramic Repair Fluid.
