Containment Area Repair

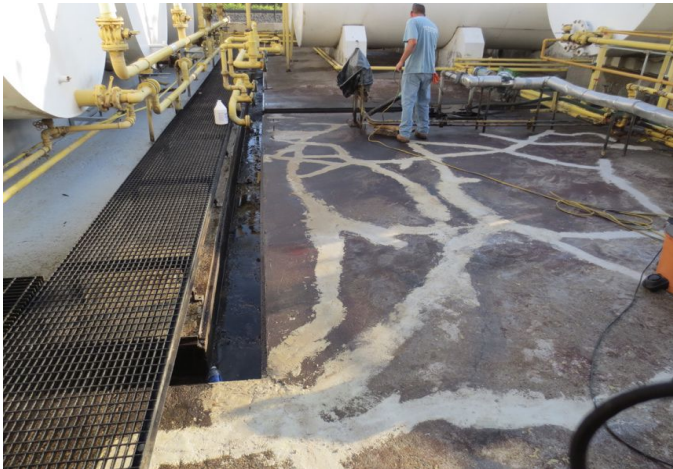
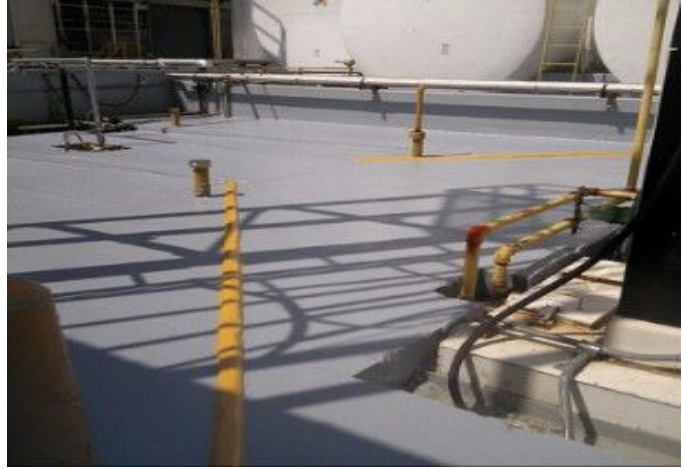
The EPA was about to fine this automotive engine manufacturer for the condition of their secondary containment. One of the issues was that if this tank leaked, the flow of this containment area was going to be in the wrong direction.

As you can see, we repaired many cracks, but also added burms to make the flow go in the proper direction. The product used here was [Resichem 576 Quartz Screed](#).

After repairing the concrete and adding the burms, Unconventional Solutions sealed the area with [Resichem 571 Concrete Repair LW](#) and [Resichem 503 SPEP](#).

USI then coated the yellow striping with [USI Fast Striping Line Marker](#).
