Project: Natural Gas Pipeline Repair

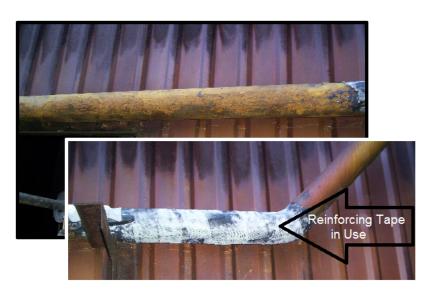
The corrosion on this natural gas pipeline that fuels a gas burner in an aluminum plant was in critical need of repair.

Brass, "non-sparking" tools and brushes were used to achieve an SSPC-SP 2 surface profile, to ensure the safety of the people and the plant. The pipe was then cleaned with USI Universal Cleaner and coated with USI Metal Repair EG. The pipe was strengthened with Reinforcing Tape, followed by another coat of USI Metal Repair EG.

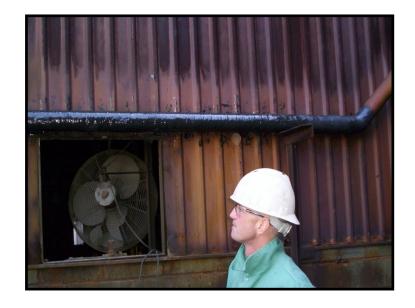
Due to the inability to grit blast the pipeline's surface, Unconventional Solutions was only able to offer a six month guarantee. *More than six years later, this pipeline is still in service.*
