## Project: Shaft Rebuild

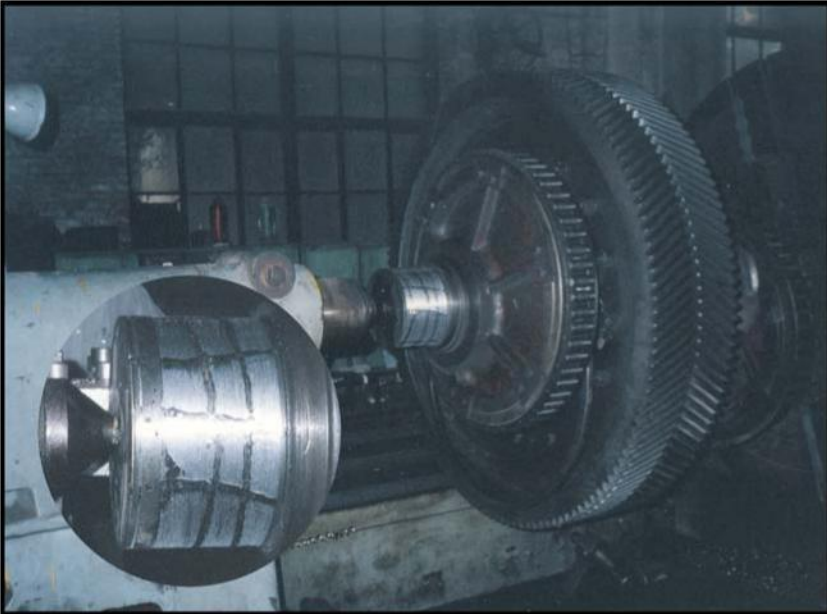
The power station shaft shown in the photograph had worn out due to years of service and was repaired by welding several years ago. A recent maintenance inspection at the power station revealed that the shaft had worn out once again.

The plant manager decided to use **USI Metal Repair EG** to rebuild this important piece of machinery. The worn section of the shaft was suitably prepared, ensuring that any loose material and surface contaminants had been removed.

The metal surface was roughened by mechanical means and degreased using **USI Universal Cleaner** prior to the application of **USI Metal Repair EG**. After the minimum cure time of 2 hours, the shaft was then machined back to its original diameter.
