Natural Gas Pipeline Repair

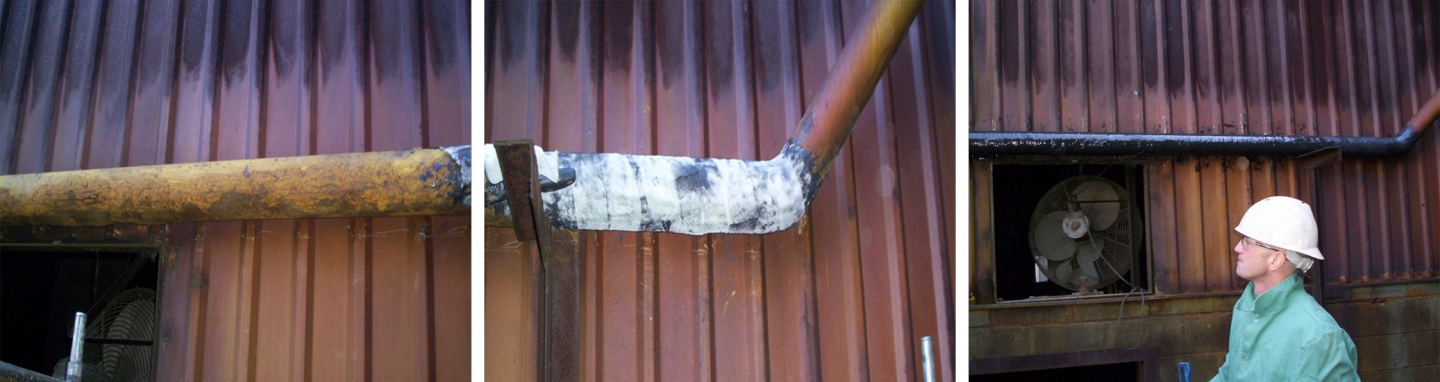
The corrosion on this Natural Gas Pipeline that fuels a Blast Furnace in an aluminum plant was in critical need of a corrosion resistant repair that would also build up wall thickness.

Brass non-sparking tools and brushes were used to achieve an SSPC-SP 2 surface profile, to ensure the safety of the people and the plant. The pipe was then cleaned with [USI Universal Cleaner](#) and was coated in [RESIMETAL 101 Metal Repair Paste](#). The pipe was strengthened with [Resimac 808 High Strength Reinforcement Mesh Tape](#) followed by another coat of [RESIMETAL 101 Metal Repair Paste](#).
