Project: Shaft Repair 1

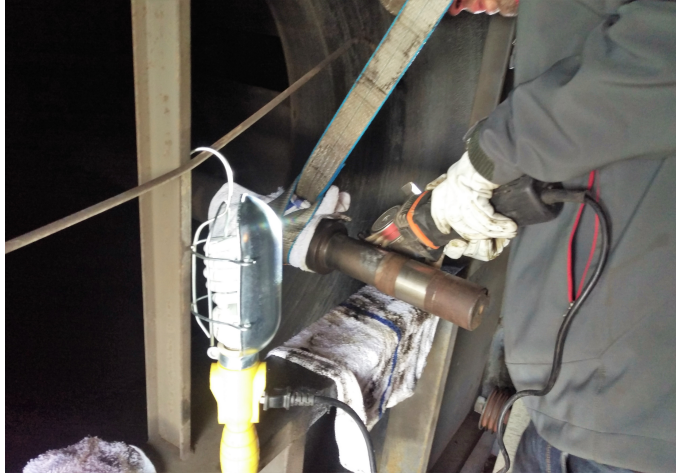
The area was prepped and prepared with the Monti Tools Bristle Blaster

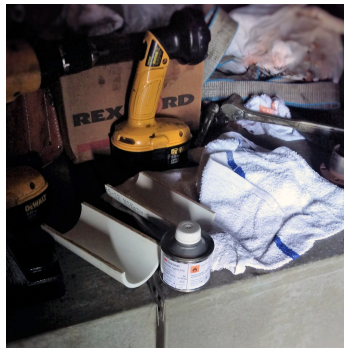
USI Metal Repair EG was properly mixed

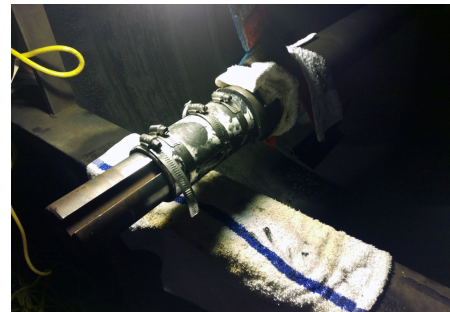
Hose clamps were then used to hold the PVC pipe and heat was applied to force cure

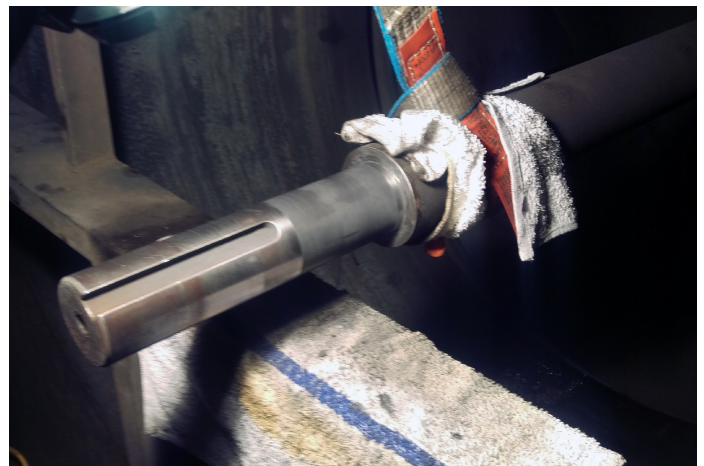
This shaft was allowed to finish curing and was back in service within 48 hours
