## Fan Impeller Refurbishment

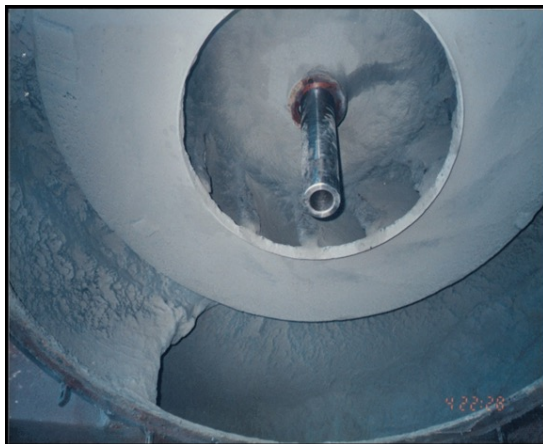
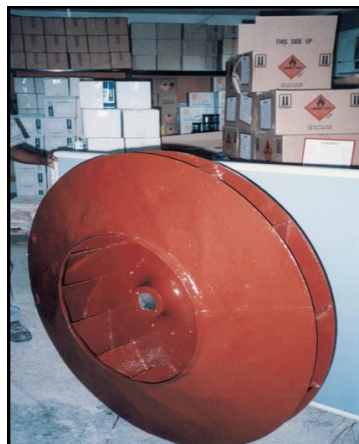
The carbon steel impeller of this dust extraction fan had been subjected to heavy wear as a result of the very aggressive operating conditions. The fan is used to extract gas with abrasive iron dust.

All loose material was scraped away. The surface of the impeller was degreased using the [USI Universal Cleaner](#) and blast cleaned to a minimum industry standard of NACE 2.

Our multi-purpose [RESIMAC 201 Ceramic Repair Paste](#) was used to rebuild the deeply pitted areas prior to the application of two coats of [RESIMETAL 202 Ceramic Repair Fluid](#).
