Turbine Refurbishment

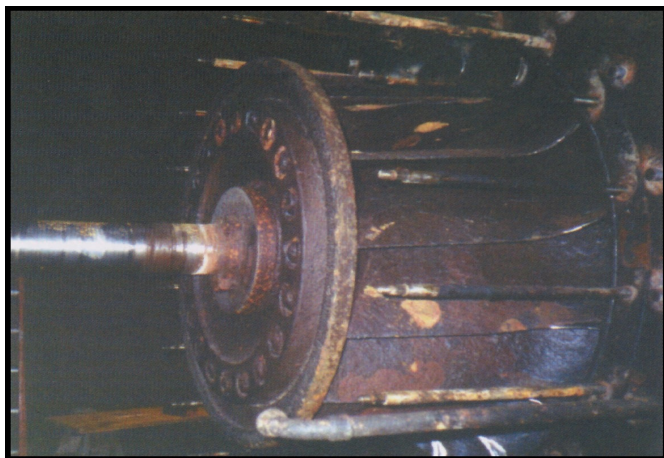
This turbine was originally built in 1923 and was used in a hydro-electric power plant.

The whole turbine was badly worn after years of use without protection. A protective coating was required to protect the equipment from future erosion, corrosion, and cavitation attack.

The turbine was dismantled, and all metal surfaces were abrasive blasted to SA 2-1/2.

All blasted surfaces were then coated with [RESIMETAL 201 Ceramic Repair Paste](#) which was applied at approximately 1mm.

Then two coats of [RESIMETAL 202](#) were applied. The first coat was red and was followed by a coat of gray. This system is used so that areas that need preventative maintenance can be easily identified.

The turbine was then reassembled and put back into service.
