Emergency Watermain Repair of a Corroded 24" Pipe

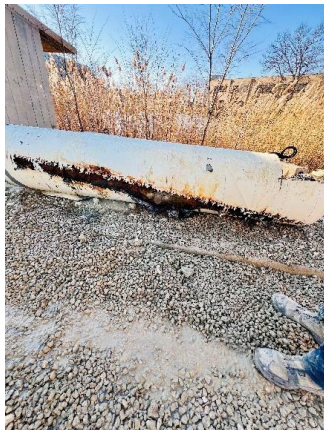
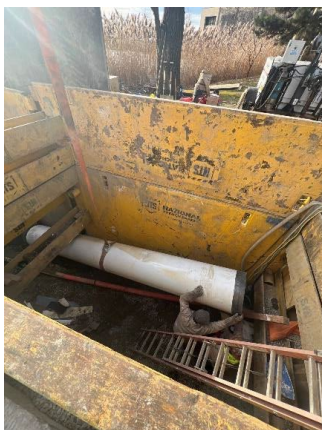
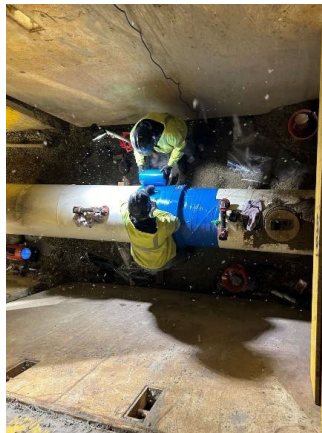
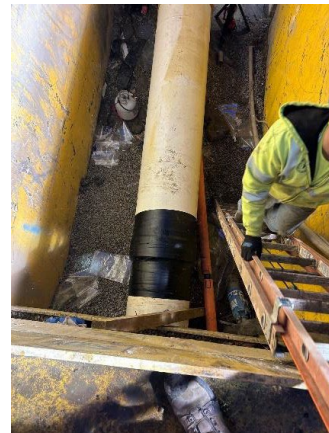
A 24" engineered steel watermain, which was previously protected with cold applied tape, encountered an unforeseen accident. It was struck by a fiber optic directional bore, causing a score at the bottom of the pipe. Over time, the damaged area succumbed to corrosion, and rust permeated through the steel, leading to the need for urgent repairs to prevent water loss and maintain service integrity.

1. Pipe Assessment and Removal: A section measuring 13 feet of the damaged 24" watermain was cut out.

2. Pipe Replacement: A new 13-foot section of steel pipe coated with fusion-bonded epoxy was prepared.

3. Welding and Securing: The new pipe section was securely welded into place with new butt straps.

4. Corrosion Protection Application: After the welds were completed, [Viscotag ST](#), a visco-elastic sealant tape, was wrapped around the welded seams.

5. Outer Protection: To provide additional protection and mechanical strength, [Viscotag PVC Outerwrap](#) was applied over the Viscotag ST. This outerwrap ensured that the entirety of the repair site was shielded from environmental factors.
