Corroded Chiller Refurbishment

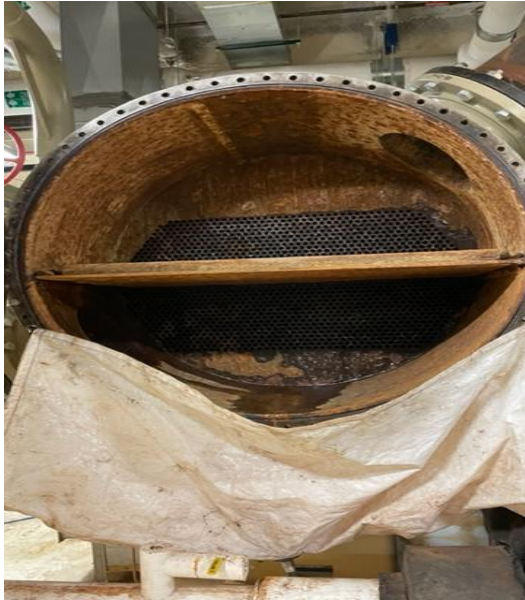
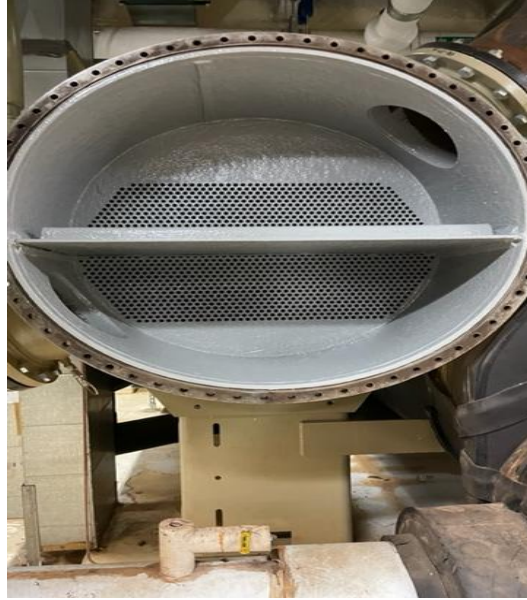
Our client had existing chillers that had never been coated before. Upon inspection they noticed a lot of galvanic corrosion on the tube face sheet and lid of the chiller.

Carbon steel and copper tube sheets

The USI crew came in and set up tents to contain the end of the chillers for dust control.

We corked the tube sheets to prevent blast media from entering the tubes.

We sandblasted the chiller ends to remove corrosion and achieve the proper profile. After sandblasting we vacuumed the area.

We then applied two separate coats of Duomar SAR Standard Abrasion Ceramic to any pitted or damaged areas.

We then applied two separate coats of Duomar EAC Ceramic Lining. One coat in red and an overcoat in grey.
