Trench Repair

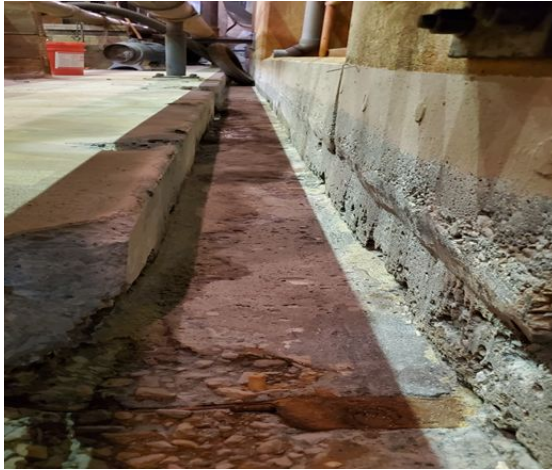
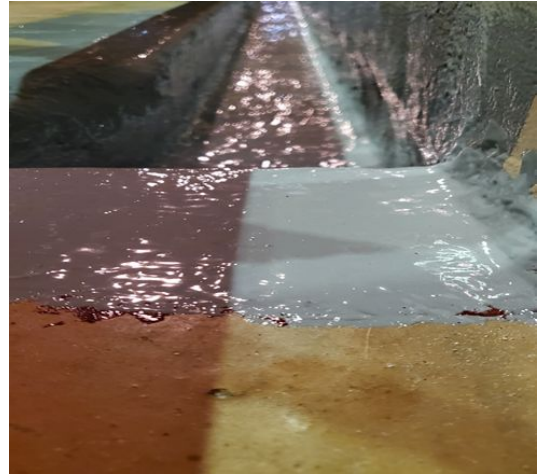
This steel mill had a severely corroded secondary containment area caused by hydrochloric acid at elevated temperatures continuously hitting their trench.

Since the hydrochloric acid was very acidic the first step was to neutralize the concrete to a neutral PH level or even to a caustic environment to a level between 7 and 10 .

After treating the area to create a neutral environment, Duromar RPC Repair Polymer Concrete was used to rebuild the areas that were eroded.

After the areas were rebuilt, one coat of Duromar DF 1303 was applied as the primer followed by two coats of Duromar HPL-4320.

One coat of Duromar HPL-4320 was applied in red and the other was applied in gray. This allows for maintenance crews to visually see when the coating is wearing off and a recoat is needed.
