School Shower Block

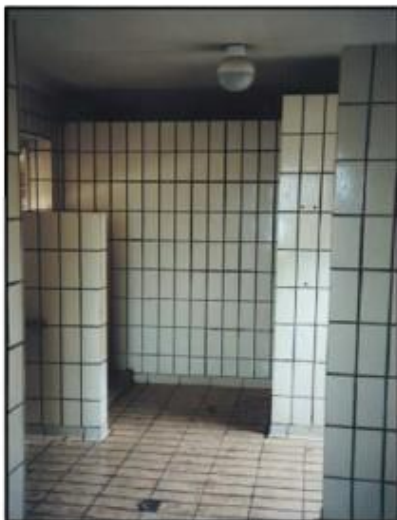
In a local school, the shower cubicles were in a deteriorating state, posing health and safety concerns. The tiles on the walls were beginning to detach, and the grout in several areas was failing, leading to bacterial growth. Additionally, the floor tiles and skirting were in such poor condition that water was seeping through the joints, further exacerbating the issue.

- Cleaning and Preparation:** The walls and floors of the shower cubicles were thoroughly cleaned to remove any dirt, grime, and bacteria.

Following this, Sase Grinding was employed to achieve the proper anchor profile, ensuring that new materials could adhere effectively.

- Repair and Patching:** Damaged areas were skillfully repaired using the 888.110 USI Epoxy Mortar Patch Kit. This product is designed for robust and durable repairs, ideal for high-moisture areas like showers.

- Priming:** All surfaces were then primed with 888.139.2 USI Flexible Broadcast Primer to ensure a strong bond for the subsequent layers.

- Sealing and Finishing:** Finally, a coat of 888.449 USI Polyaspartic Sealer in White was applied. This not only provides a fresh and clean appearance but also a hardwearing and hygienic surface. Light aggregate, specifically 46 (5gallon) USI White Aluminum Oxide, was broadcast throughout the floor area to enhance slip resistance, an essential feature for safety in wet environments.
