Emergency Watermain Repair of a Corroded 24" Pipe

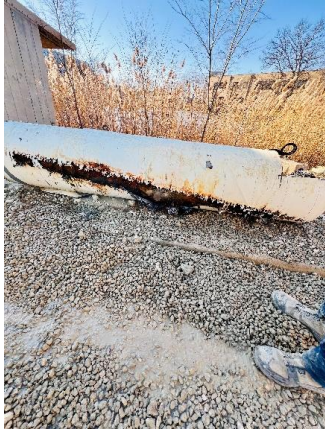
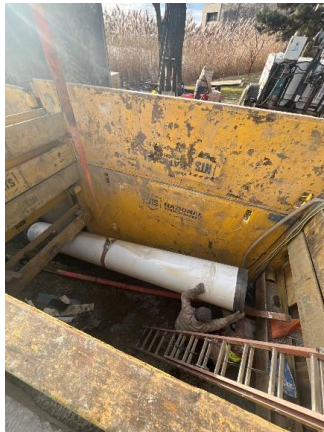
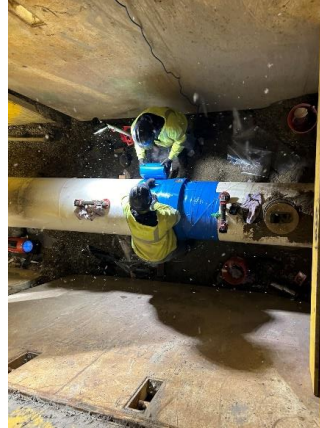
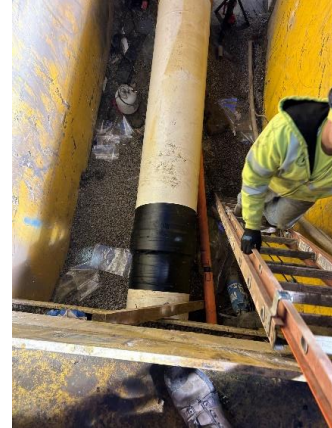
A 24" engineered steel watermain, which was previously protected with cold applied tape, encountered an unforeseen accident. It was struck by a fiber optic directional bore, causing a score at the bottom of the pipe. Over time, the damaged area succumbed to corrosion, and rust permeated through the steel, leading to the need for urgent repair to prevent water loss and maintain service integrity.

A section measuring 13 feet of the damaged 24" watermain was cut out.

2. Pipe Replacement: A new 13-foot section of steel pipe coated with fusion-bonded epoxy was prepared.

3. Welding and Securing: The new pipe section was securely welded into place with new butt straps.

Application: After the welds were completed, Viscotaq ST, a visco-elastic sealant tape, was wrapped around the welded seams.

5. Outer Protection: To provide additional protection and mechanical strength, a PVC Outerwrap was applied over the Viscotaq ST. This outerwrap ensured that the entirety of the repair site was shielded from environmental factors.
