# Unconventional Solutions, Inc.

## Project: Coal Separator Rebuild

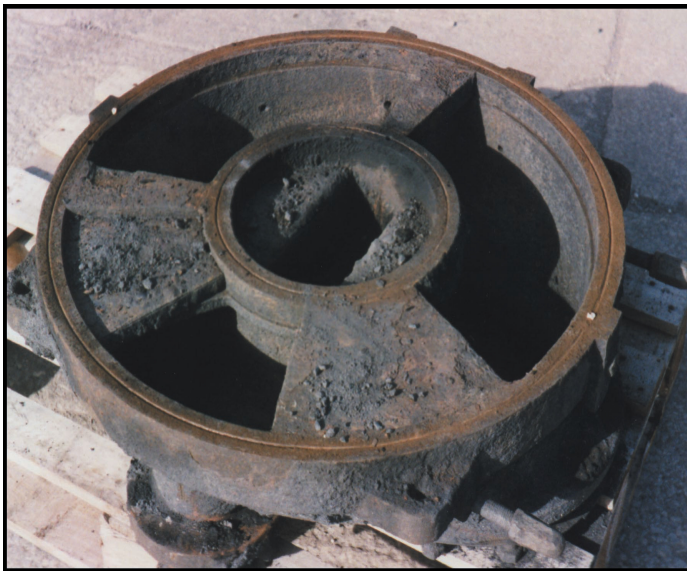
This photograph shows part of the coal separation unit in a coal preparation plant.

After continual use over an extended period of time, this piece of equipment had eroded and corroded badly because the separator was subjected to high levels of abrasion.

All dirt and contamination was removed from the surface, and then the separator was blasted to provide a good profile.

The badly pitted areas were rebuilt with **USI Ceramic Rebuild** and two coats of **USI Ceramic Lining FG** were applied to the entire surface.

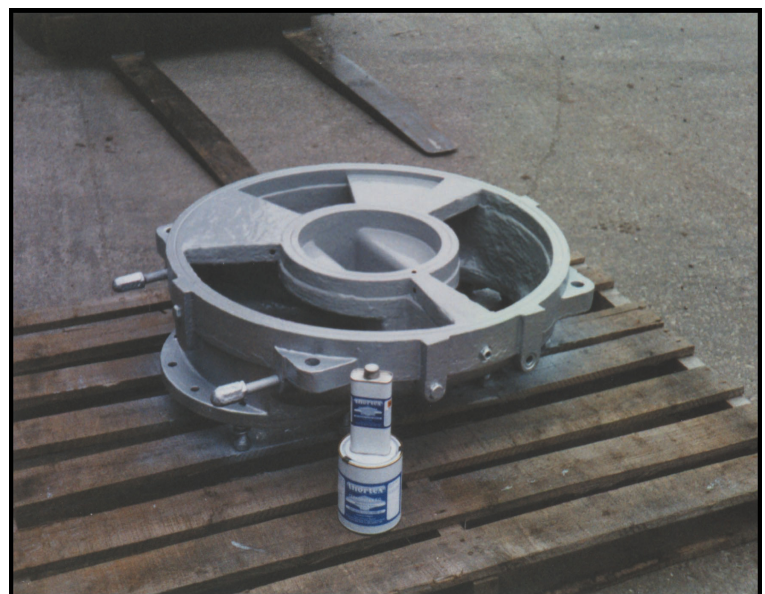
This has proven to be an ideal system for rebuilding this piece of equipment, now operating perfectly at a fraction of the cost.
