Tank Chime Repair

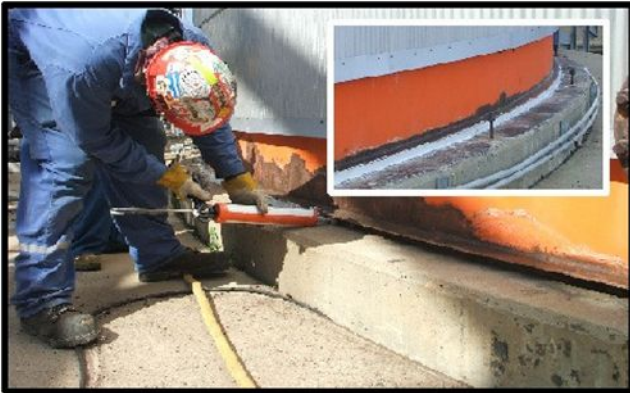
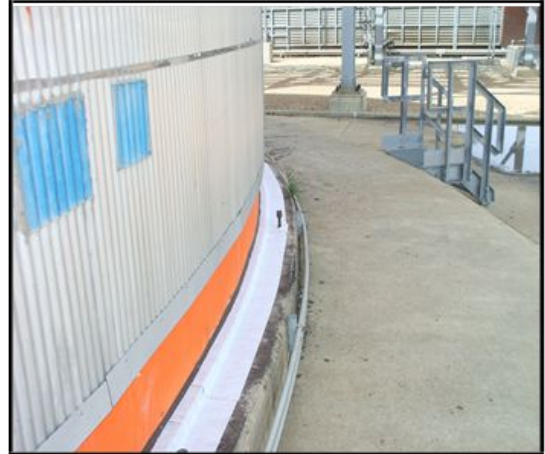
A wastewater company was looking for a cost-effective and durable repair solution for their tank chimes. There was a 1½in. gap that needed to be repaired and sealed.

Unconventional Solutions used a viscous elastic Viscotag Sealant, a mastic-like paste with synthetic properties to seal the gap at the base of the tank chime.

To protect from further corrosion, the sealant was then covered with a 70mil viscous elastic Viscotag E-Z Wrap that can be painted immediately.

Since the floor plate of a tank is constantly moving during the filling and emptying process, the permanent flexibility and aggressive adhesion of this viscous elastic system is ideal for tank chime areas.

The we painted the Viscotag E-Z Wrap with RESICHEM 555 Resinox for long-lasting, aesthetically-pleasing corrosion protection.
