Unconventional Solutions, Inc.

Project: Tank Chime Repair

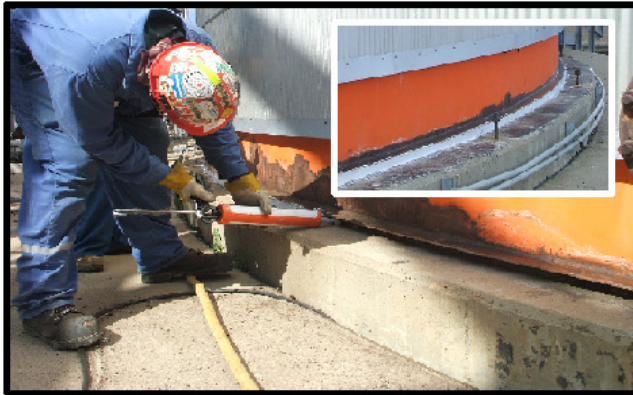
A waste water company was looking for a cost-effective and durable repair solution for their tank chimes. There was a 1½in. gap that needed to be repaired and sealed.

Unconventional Solutions used a viscous elastic sealant, a mastic-like paste with synthetic properties to seal the gap at the base of the tank chime.

To protect from further corrosion, the sealant was then covered with a 70 mil viscous elastic wrap that can be painted immediately.

Since the floor plate of a tank is constantly moving during the filling and emptying process, the permanent flexibility and aggressive adhesion of this viscous elastic system is ideal for tank chime areas.
