Project: Big 10 University Chiller - 2018

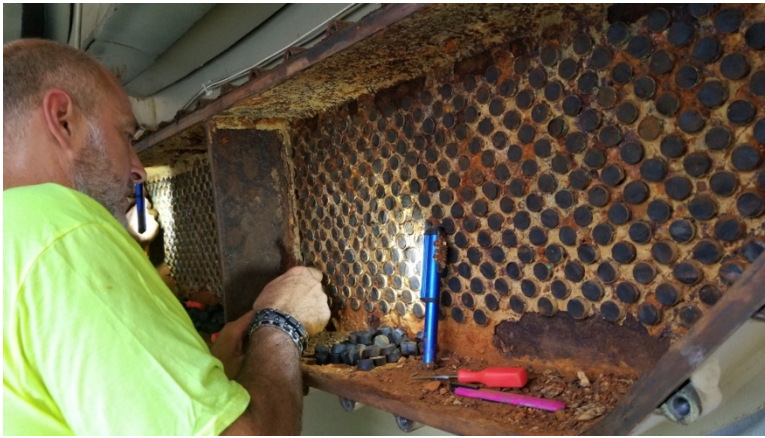
A Major Big Ten University was experiencing galvanic corrosion, also known as bimetal corrosion, which was eating away at the metals and causing tubes to plug. This Michigan University wanted to lower their energy cost and felt a hydrophobic ceramic enhanced polymer coating would provide a smoother surface and reduce energy bills. Having worked with the USI Team before, they called us in to work on this important project.

The USI Team tented the area to create an exhaust/dust free environment. Corrosive Materials and Blast Media were put into a dumpster for disposal by the client. The tubes were corked to prevent abrasive blast media from going into the copper tubes. The USI Team first abrasive blasted to NACE 2 specifications, to a 2 1/2 to 4 mil anchor pattern. Next, the USI Team rebuilt lost metal around the tubes with a paste grade ceramic engineering rebuilding product. Lastly, two coats of a ceramic fluid grade material were brush applied by the USI Team to give it a smooth, hydrophobic finish to be more efficient and provide an erosion corrosion free environment.
