Bronze Impeller Refurbishment

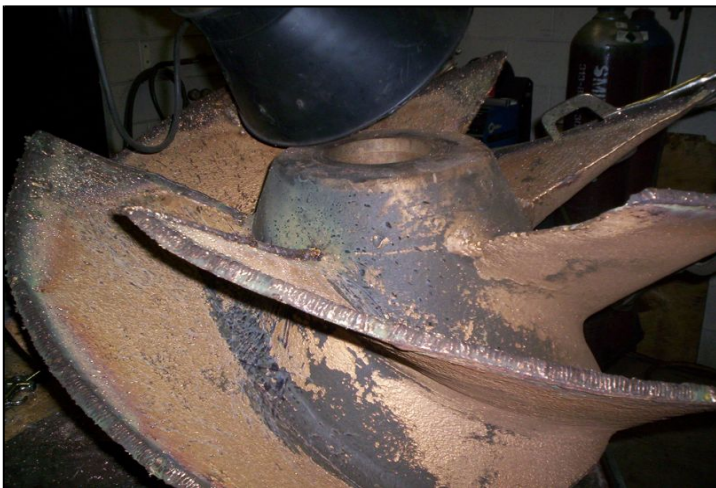
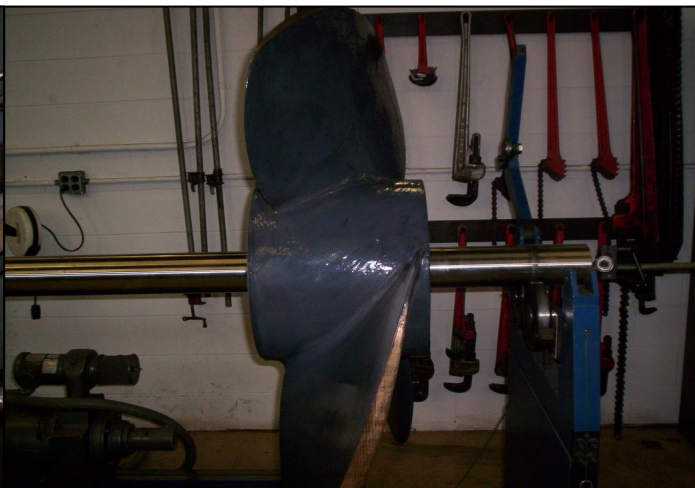
A power plant on a lake had a bronze impeller that suffered extensive corrosion and, in some spots, severe deterioration of the base metal.

The surface of the impeller was blast cleaned to a minimum of NACE Grade 2. One coat of RESIMAC 201 Ceramic Repair Paste – a reinforced repair – was used to give excellent abrasion resistance. RESIMAC 201 Ceramic Repair Paste is simple and safe to use and designed for areas subjected to cavitation and impact damage.

Two coats of RESIMETAL 202 Ceramic Repair Fluid were then applied to give extra protection and a smooth finish to the impeller.
