Scroll Case Refurbishment

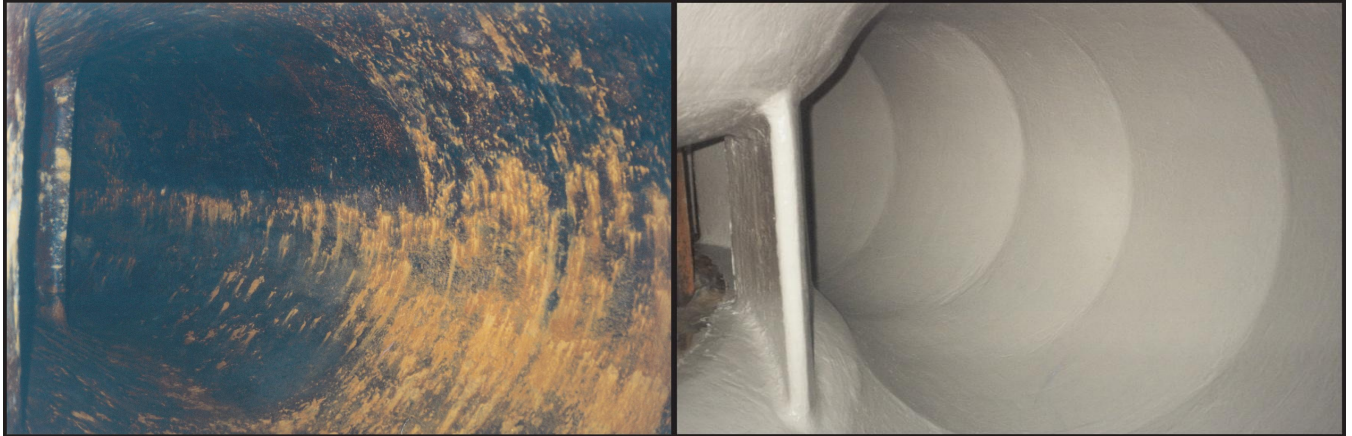
Thousands of liters of water had been continuously pumped through the scroll, which was 120 feet long and had a diameter of 12 feet, to service the requirements of the hydro-electric power station.

The internal surfaces, totaling 1,230 square feet, had deteriorated significantly due to the volume of water and high level of use. It was now in need of complete refurbishment.

A total of 1,118 pounds of [RESIMETAL 201 Ceramic Repair Paste](#) were first trowel applied. A stiff bristled angled paint brush was used to smooth out the high spots and uneven areas. A thickness of 750 microns was achieved.

In order to achieve the required finish, the surface of the [RESIMETAL 201 Ceramic Repair Paste](#) was sandblasted. After removing resultant dust, a thin coat of [RESIMETAL 209 EIP PU](#) was roller applied over the entire surface.
