Project: Rotary Lobe Blower Refurbishment

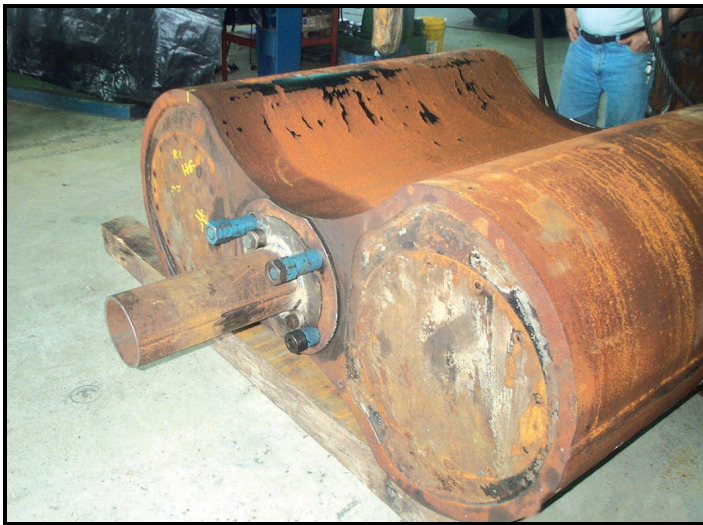
The Process Gas Compressor was disassembled and the casing, rotors, and head plates were found to be severely eroded and corroded.

The rotors were abrasive blasted. All deep areas were filled with **USI Ceramic Rebuild** and leveled to provide a suitable base to rebuild on. Two coats of **USI Ceramic Lining FG** was applied for low friction.

The same procedure was carried out on the head plates. The casing was rebuilt using **USI Metal Repair EG** leveled and finished with one coat of **USI Ceramic Lining FG**.
