Crude Oil Pit Rebuild and Protection

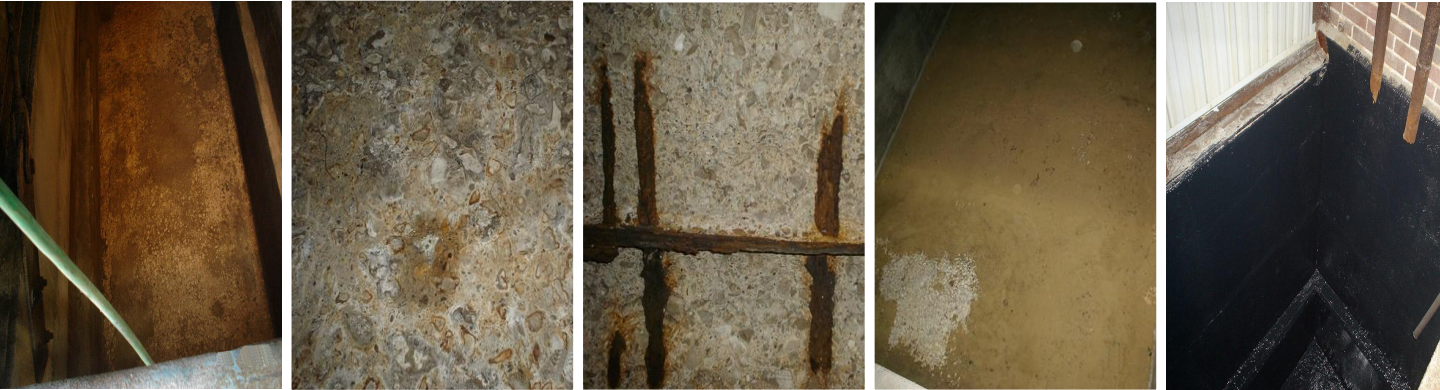
This old crude oil pit was severely decayed.

To accommodate the customer's request, Unconventional Solutions suggested the use of fine sand and RESICHEM 502 CRSG to get a bulk fill.

[RESICHEM 501 CRSG](#) was used a second time to coat the existing concrete before using two coats of RESICHEM 502 CRSG.

Epoxy coating was used to protect the pit from the crude oil along with anything else which may come in contact with the pit.
