## Project: Stainless Steel Conveyor Dearborn, Michigan

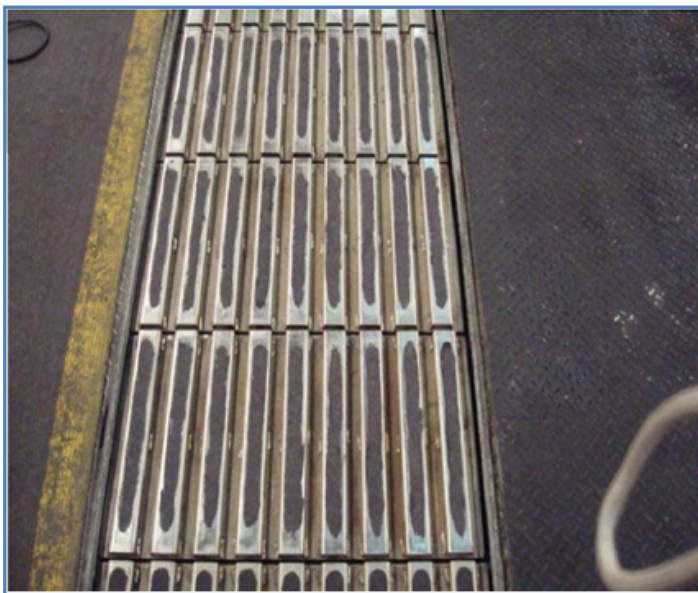
### The Problem

This stainless steel Flat Top Conveyor in a local Auto Plant was constantly getting wet causing a major slip hazard to the assembly drivers.

The conveyor was cleaned and coated with our **3M Scotchkote Epoxy Coating 152 LV** with **3M Scotchkote LD Grip 092** system to offer the assembly plant a long term solution over the conventional safety tape.
