## Wastewater Treatment Plant Containment Area Protection

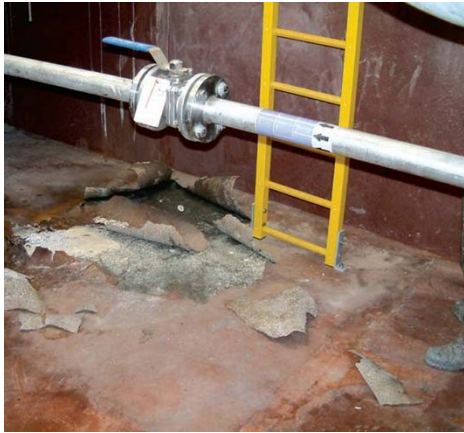
The original coating had failed following an incident when a valve had leaked and 3 quarts of 95% sulfuric acid had spilled onto the containment area lining.

As can be seen from the photograph, the sulfuric acid had caused severe damage to the coating and had chemically attacked the concrete.

The substrate was lightly abrasive blasted to clean and remove the existing coating,

The concrete was rebuilt using RESICHEM 576 Quartz Screed. Then we primed the surfaces with RESICHEM 505 Damp Seal

We then applied two coats of RESICHEM 511 UCEN to provide exceptional resistance to chemical attack even under permanent immersion conditions in up to 98% sulfuric acid. It is ideal for the long-term protection of tanks, pipe work, containment areas, and dykes.
