Project: Airport Taxi Way

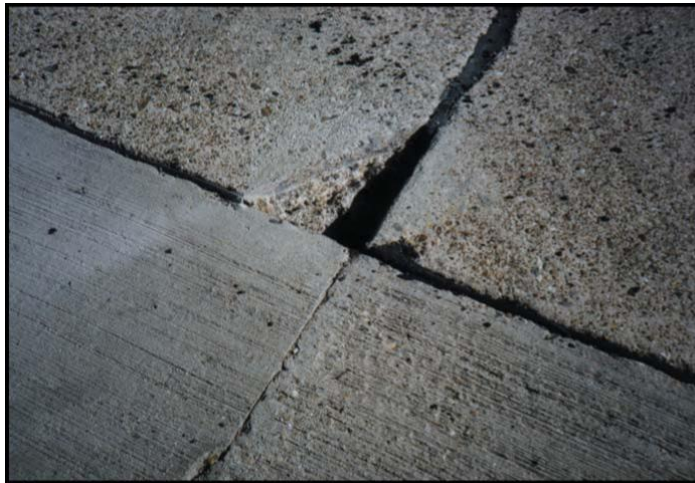
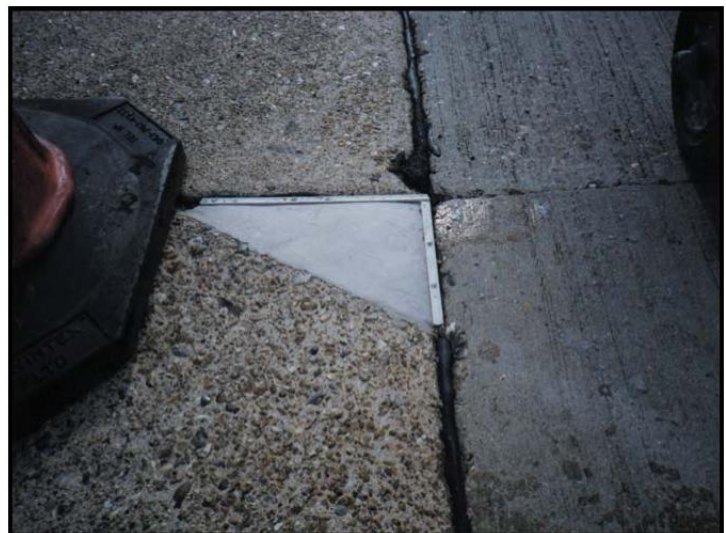
The airport was suffering from the continual breakdown and chipping of the arris edges of the concrete slab on the taxiway where they are jointed. This was a continual problem due to the compressive forces of the aircraft nose wheels and the added problem of extreme weather cycle exposure. Extensive areas needed repair and being one of the busiest airports in the world, the timescale was limited.

Trials using **USI Concrete Repair LW** were carried out in the summer and monitored throughout the winter. The surfaces were prepared with scabblers to leave a good edge prior to the application of **USI Concrete Repair LW**. The areas for repair were only available for 7 hours throughout the night and all repairs had to be cured to a compressive strength of 20 N/mm. This was achieved by keeping the unmixed product warm prior to application and adding heat to the repaired areas to speed up the cure time. The repairs proved a complete success with the regular flow of aircrafts using the taxiway the following morning.
