Project: Automotive Tunnel

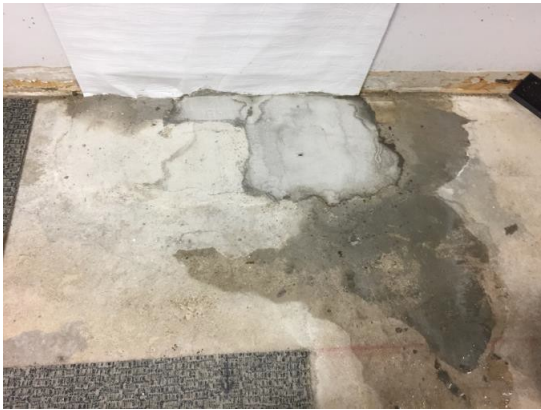
This automotive company had a tunnel that was leaking for over ten years.

Our team went in and started prepping the floor and while peeling the base board off the wall discovered that the leak was even coming through the wall.

After scraping out 4 inches of wet concrete in the wall and almost 10 inches on the floor the **USI Group** used **USI Fast Plug** to stop the leaks. This is a single component fast curing water active cementitious coating that arrests water seepage and infiltrates through cracks and voids in concrete and masonry.

After USI stop the active leak we top off the area with **USI Waterproofing Compound CWC**. **USI Waterproofing Compound CWC** is a cementitious polymer which reacts with concrete and cement structures to provide a chemically bonded waterproofing layer the resists hydrostatic pressure to 150 psi. The project has now been in service for over 8 months and the customer has invited USI back to do three more projects in the future.
