Project: Concrete Joint Repair

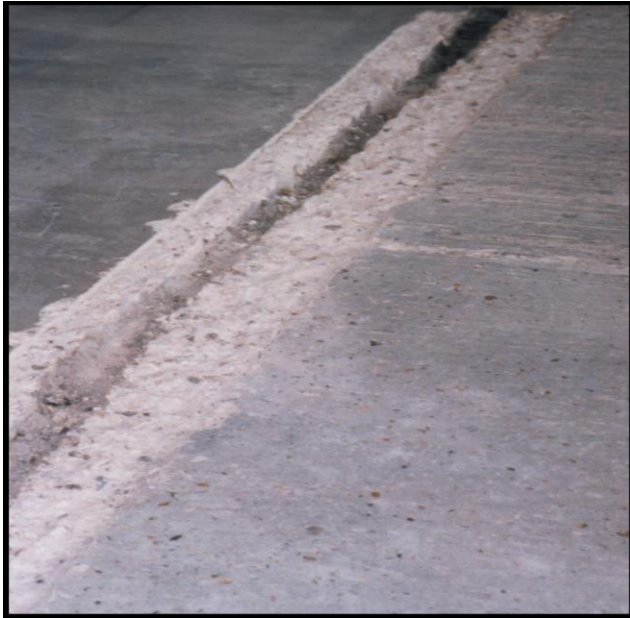
The client was having problems with a very wide movement joint (2.4 – 3.0 inches) between a building and the external concrete hard standing.

This was causing difficulties for fork-lift truck drivers who were having back problems due to the jolting when driving over the uneven surface and they were losing loads off the forks, resulting in delays and damage to goods.

The solution to the problem was to reduce the joint to 0.4 inches, and to provide a smooth surface across the joint.

Two 0.4 inch deep slots were cut in the concrete on either side of the wide or uneven surface of the joint. The concrete was chased out at this depth forming a recess 0.4 inch deep. The area was cleaned and primed. A 0.4 inch timber batten was used to form the joint, and the void was filled with **3M Scotchkote Screed RS 820**. The joint was then filled with **3M Scotchkote Elastomer 60 EG 533**.

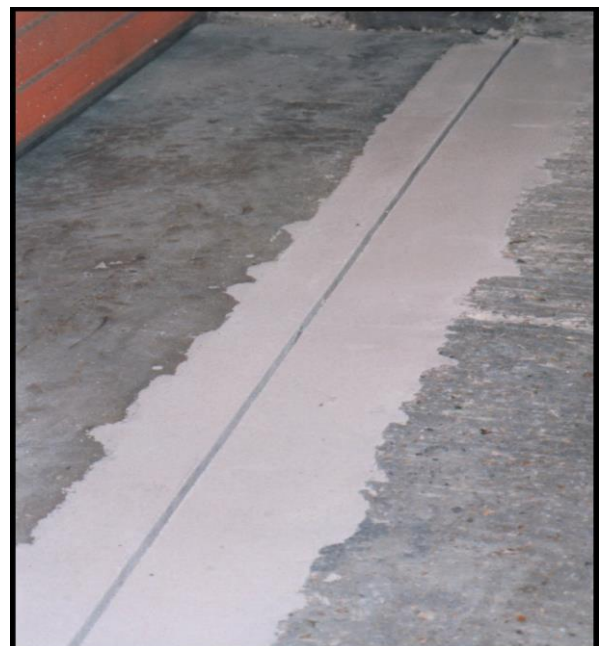
Based on the success of this work, the client wants to look at carrying out repairs to additional joints in the concrete aprons outside the building.
