Project: Hospital Heliport Repair

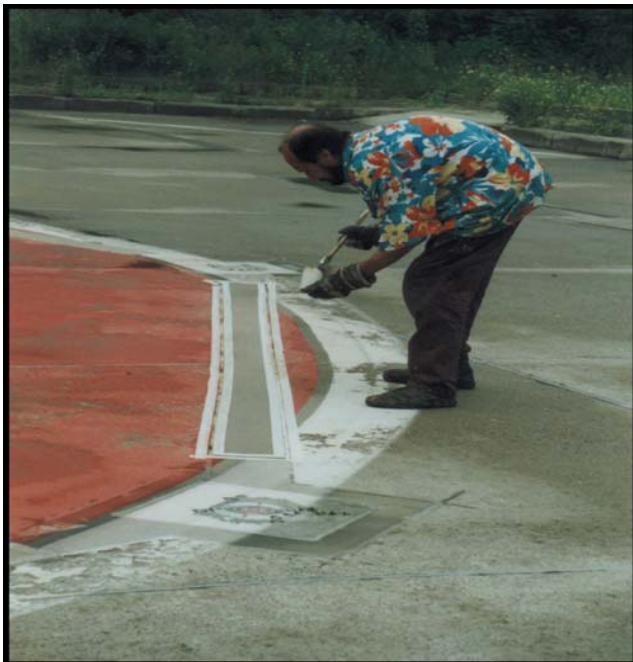
The lights and cables around the landing area needed replacing. The heliport could only be out of use for a short period of time, and a repair system that would cause minimum disruption was a necessary requirement.

All damaged and loose concrete was removed. Channels approximately 8 inches wide and 4 inches deep were formed in the concrete.

The cables were replaced, and the damaged areas were rebuilt with **USI Concrete Repair LW**.

This repair caused minimum disruption, and after a few hours the heliport was back in service.
