Project: Cooler Tower Basin Repair

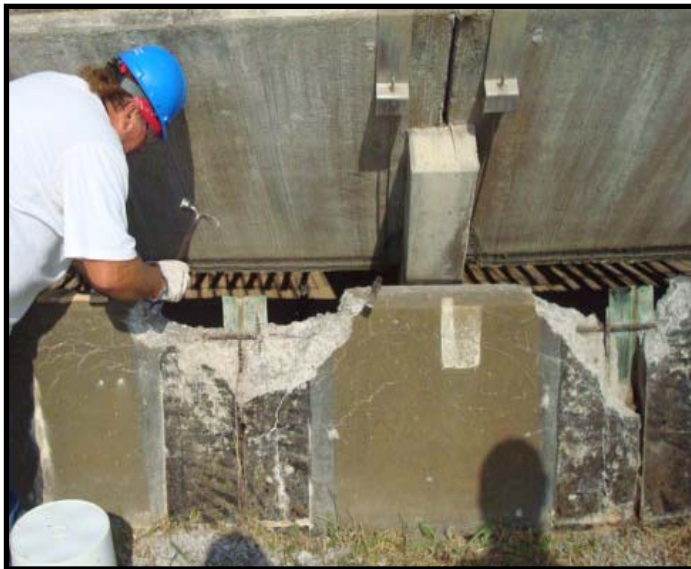
The client was having problems with this cooling tower basin at a nuclear power plant because it was in desperate need of repair. The basin was deteriorating, the concrete wall was badly cracked and wearing away and corrosion was affecting the exposed metal.

The exposed rebar was coated with **USI Ultimate Protection Coating**, a high build epoxy designed to provide excellent, long-term corrosion protection in one coat.

The damaged concrete was prepared and repaired with **USI Concrete Mortar LW**. This lightweight repair mortar is excellent for vertical or overhead surfaces. It provides a strong, durable repair to any concrete or mineral, and is 100% solid and VOC free. This lightweight mortar gives the customer 6000 psi of compression strength.
