## Cooler Tower Basin Repair

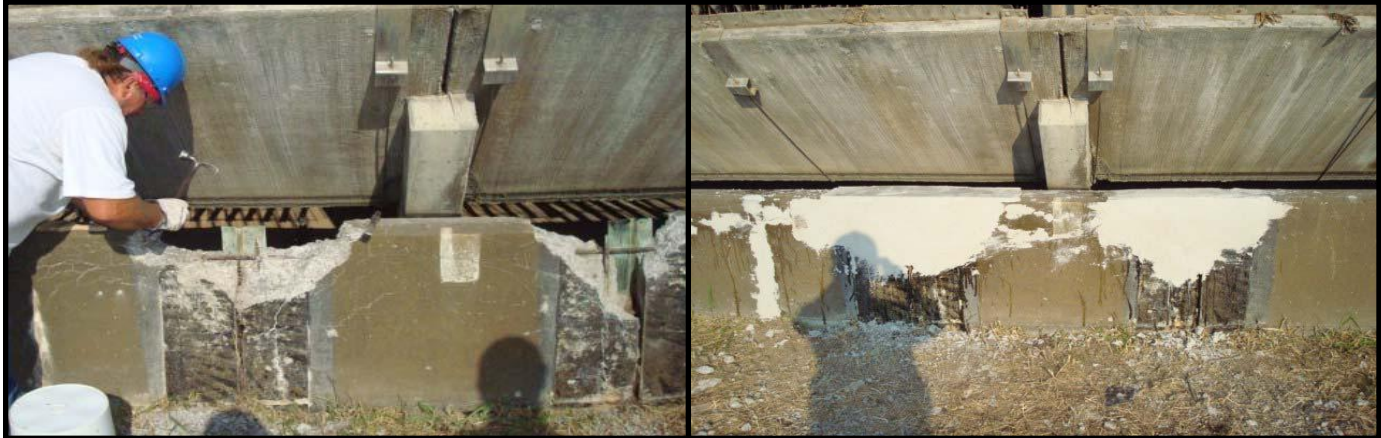
The client was having problems with this cooling tower basin at a nuclear power plant because it was in desperate need of repair. The basin was deteriorating, the concrete wall was badly cracked and wearing away and corrosion was affecting the exposed metal

The exposed rebar was coated with [RESICHEM 511 UCEN 90](#), a high build epoxy designed to provide excellent, long term corrosion protection in one coat.

The damaged concrete was prepared and repaired with [RESICHEM 571 Light Weight Concrete Repair](#). This lightweight repair mortar is excellent for vertical or overhead surfaces. It provides a strong, durable repair to any concrete or mineral, and is 100% solid and VOC free. This lightweight mortar gives the customer 6000 psi of compression strength.
