Project: Pitted Steel Mill Floor

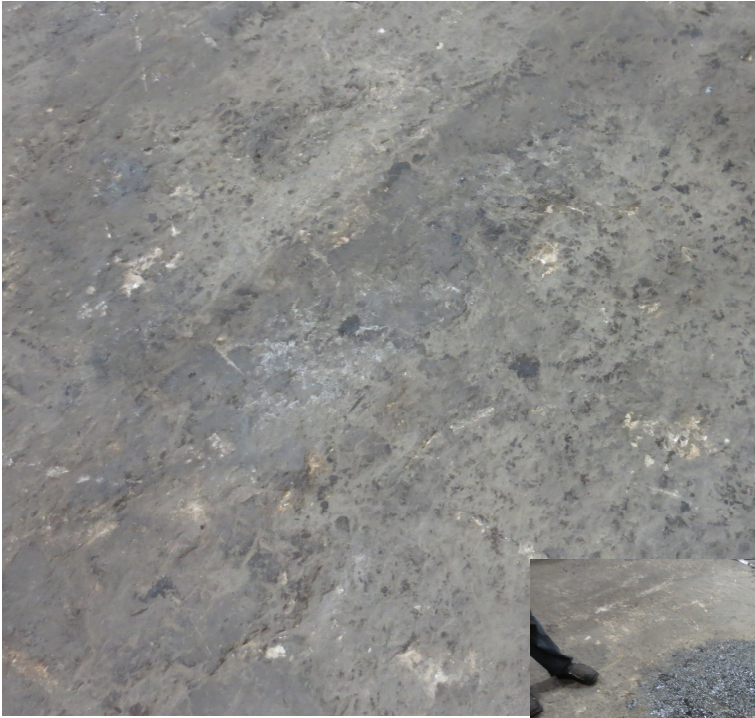
This steel mill was dealing with a lot of pitting on their floors. They were looking for a solution that could easily smooth out the floor without having to shut down for a long period of time. They also needed to eliminate trip, slip and fall issues which is the #1 OSHA reportable.

We first removed all loose dirt and debris from the area. We then primed the surface with our **3M Scotchkote Concrete Repair 474**. This is a quartz aggregate that allows you to trowel a paper thin layer to fill pitted areas. This provides a peeling savings and allows quick return to service.
