Project: Removal of Automotive Railing / Concrete Repair

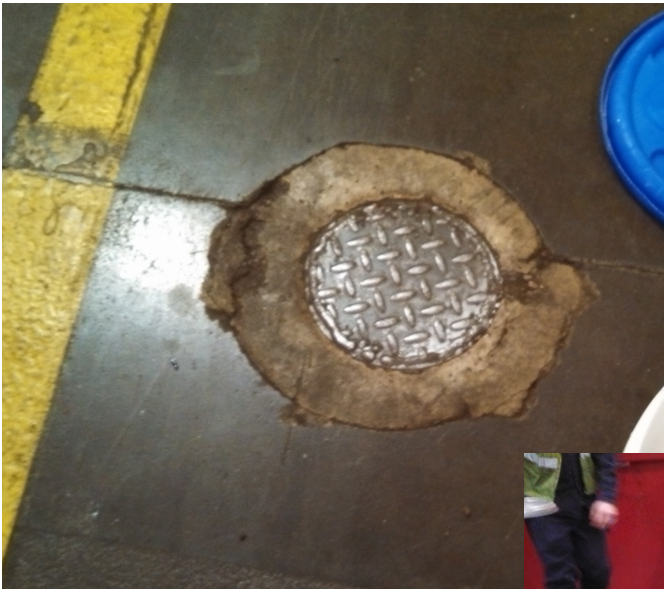
An Auto Manufacturer is removing a large number of guardrail posts to reconfigure their new body shop. When the posts are removed a 4" to 8" diameter hole is left in the concrete floor. Each hole has a steel sleeve that is approximately 24" to 36" deep. The steel sleeve needs to be filled and in many cases the floor around the top of these sleeves is damaged and needs repaired. The filler and repair need to be durable enough to withstand constant HILO traffic for many years.
