Power Company Secondary Containment Repair

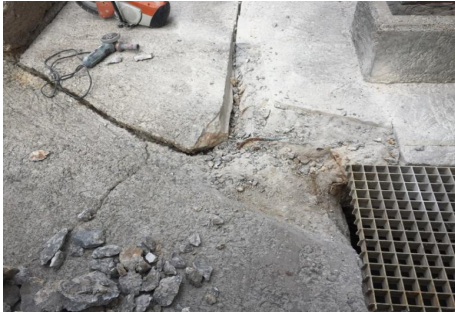
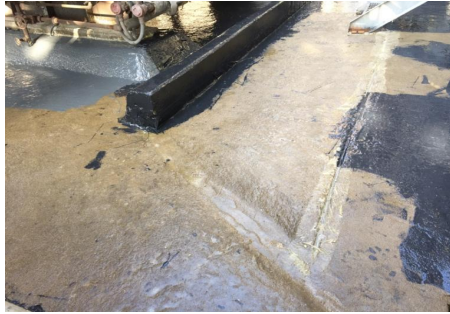
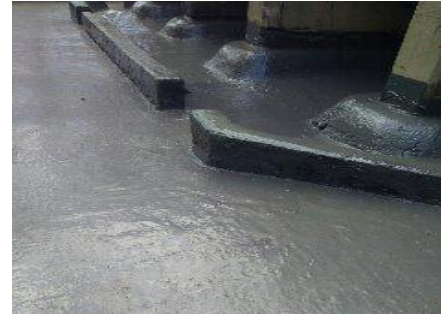
A major power company required a recommendation for the right coating and surface preparation procedures to assure them a long-time performance of their secondary containment system (50% caustic and 93% sulfuric acid), since their current coating was deteriorating. They selected USI for this recommendation.

Assessing the concrete, we decided to fix the cracks with [RESICHEM 576 Quartz Screed](#) to repair the deterioration.

The we primed the concrete with [RESICHEM 505 Damp Seal](#) before applying two coats of [RESICHEM 511 UCEN](#) for chemical resistance. We used two different colors to ensure that the first layer was covered.
