## Project: WWTP Clarifier Tank

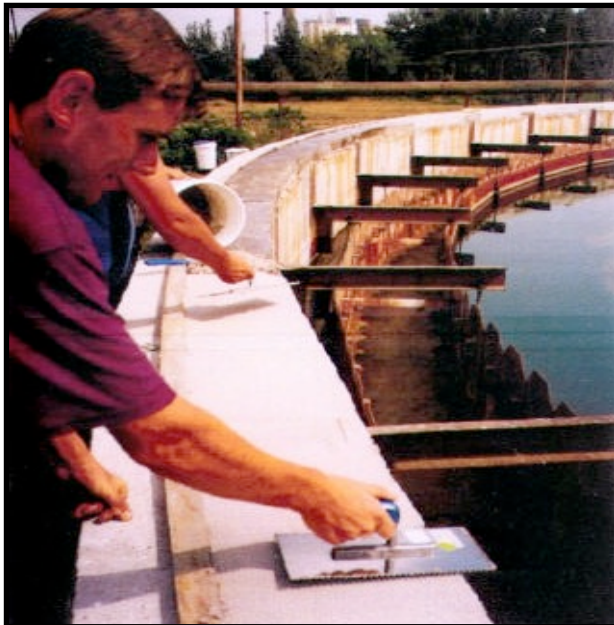
The weather had been taking its toll on the clarifier tank at this waste water treatment plant, causing the concrete to erode and begin to crumble.

The concrete surface was scarified to remove any existing coating that remained and to obtain a smooth profile. The crew used **USI Epoxy Sealer** to seal the surface and then applied **USI Quartz Screed** to rebuild the wall.
