## Project: WWTP Concrete Repair

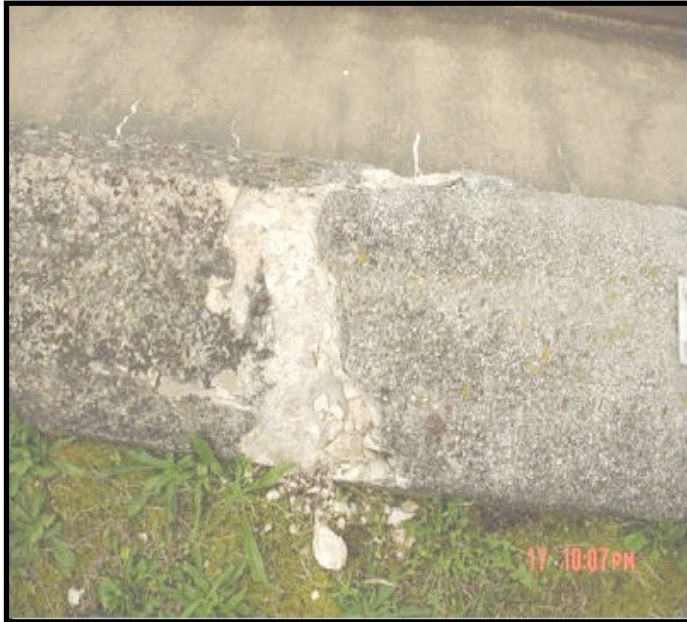
The deterioration of the concrete at this WWTP is typical because of weather conditions found in the northeastern part of the United States.

The crew assessed the damage to the various reservoir structures, and recommended **USI Quartz Creed**.

The cracked and broken concrete were abraded to a sound substrate. The surface was cleaned, and **USI Epoxy Sealer** was applied.

Before the primer was fully dried, **USI Quartz Screed** was installed.
