Project: Bearing Housing Repair

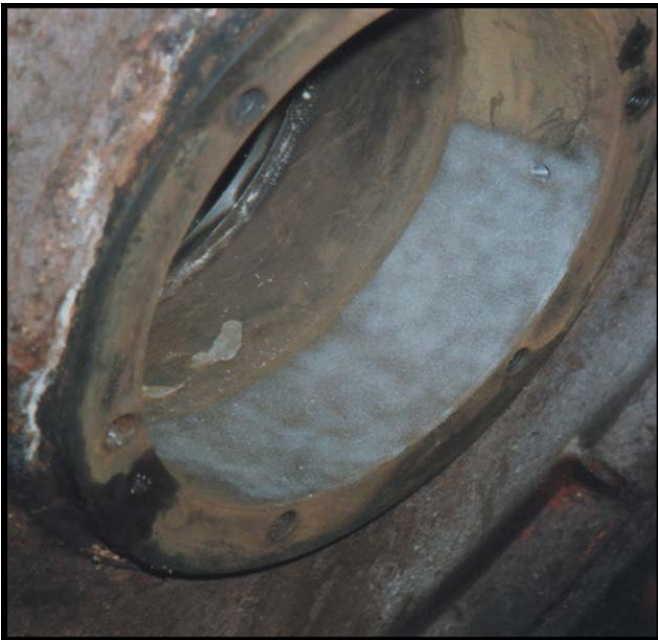
This bearing housing was very badly worn on both the inside and outside. It was in urgent need of repair so that it could be put back in service and cause minimum disruption to the normal operation of the plant.

The bearing was repaired without it having to be dismantled. The roller bearing was fixed in the housing. All gaps were sealed with **USI Metal Repair RG**. After these were sealed, **USI Metal Surfacer FG** was injected with a cartridge between the roller bearing and the bearing housing.

After only a few hours the bearing housing was back in service.
