Project: Flange Repair – Fresh Water Tank

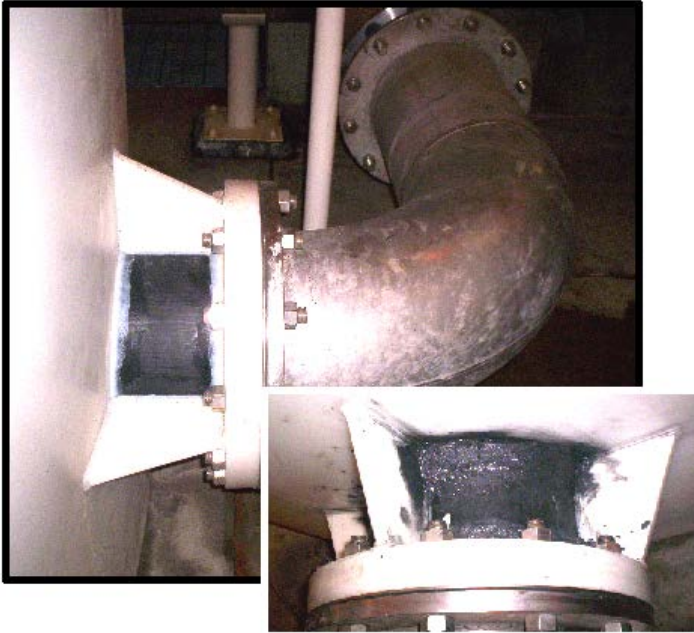
At a fresh water filtration plant in Michigan, one of the water tanks had a badly damaged flange due to the constant use and pressure from the water being pumped through to the tank.

The water source was turned off and the tank emptied in order to keep contaminants from the fresh water. The damaged area of the flange was hand abraded to provide a surface profile to ensure proper adhesion.

Unconventional Solutions solved the problem by patching the flange with **USI Metal-Tech EG**. The repair was fixed in place which saved the treatment plant lots of time and money.
