Project: Heat Exchanger Rebuild

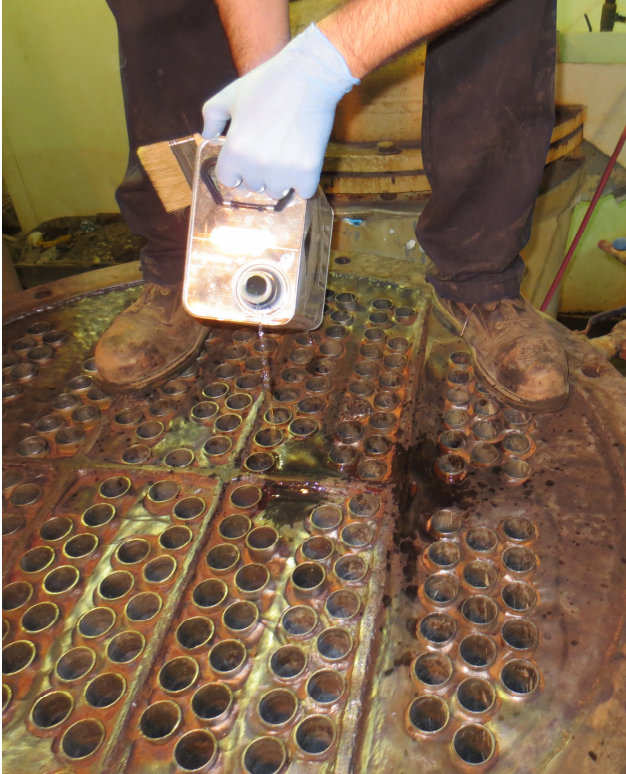
This food processing company needed a solution for their Press Water Heater. The area around the tubes had a 1/4" to 1/2" of missing metal on the face plate of the heater and it was getting worse.
