## Project: Cleat issues on a conveyor belt

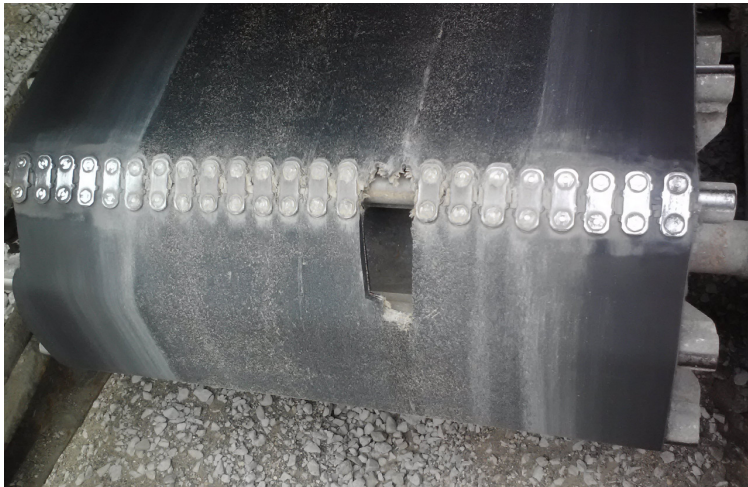
A local concrete plant was continually having problems with their conveyor belts, especially at the cleats. Since they needed to be back in service very quickly, they opted for our Rapid Repair System which allows it to be back in service the same day the repair is completed.

First, we cut out the bad cleat section so there were no obstructions in order for us to do the repair. The hole was repaired using a combination on **USI Reinforcing Tape** and **USI Elastomer Repair RG**. We used a wide cellophane tape over the cleats to allow them to still move freely over the rollers. We then coated the entire cleat section with more **USI Elastomer Repair RG**.
