Rubber Roller Refurbishment

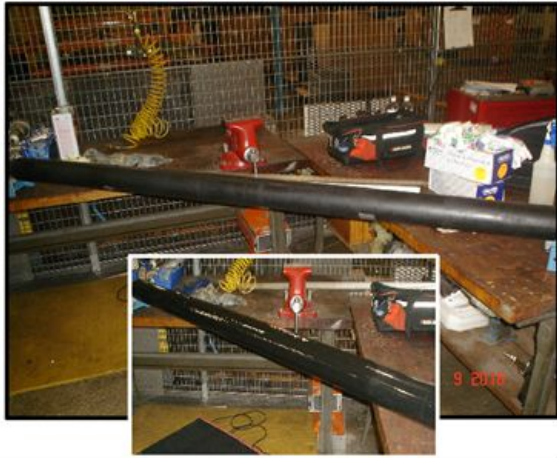
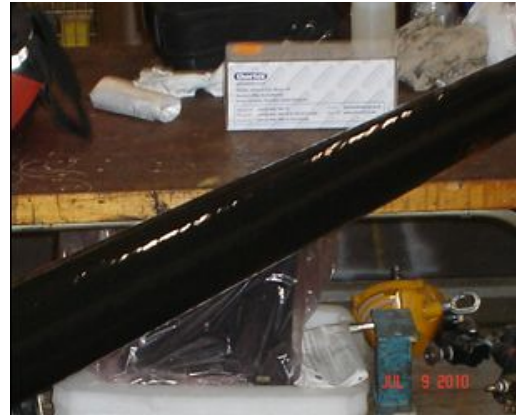
An automotive component supplier had a rubber coated roller which feeds textile blanks into a molding machine. The roller is approximately 6 ft long and 5 inches in diameter.

Because of extensive use, the rubber coating became worn which caused it to lose the strong gripping ability. This also caused misaligned loading in the center of the roller, generating more waste and a loss of productivity.

After undercutting the rubber at the edges where it had worn away, a wire brush was used to remove old loose material and provide a surface profile to ensure proper adhesion. The roller was coated with RESIFLEX 402 Multi-Surface Primer.

After the primer dried, the RESIFLEX 406 GP 85 Putty was brushed onto the surface of the roller.

Like new, the roller has regained its gripping ability and is back in production.
