## Power Plant Warehouse Floor Restoration

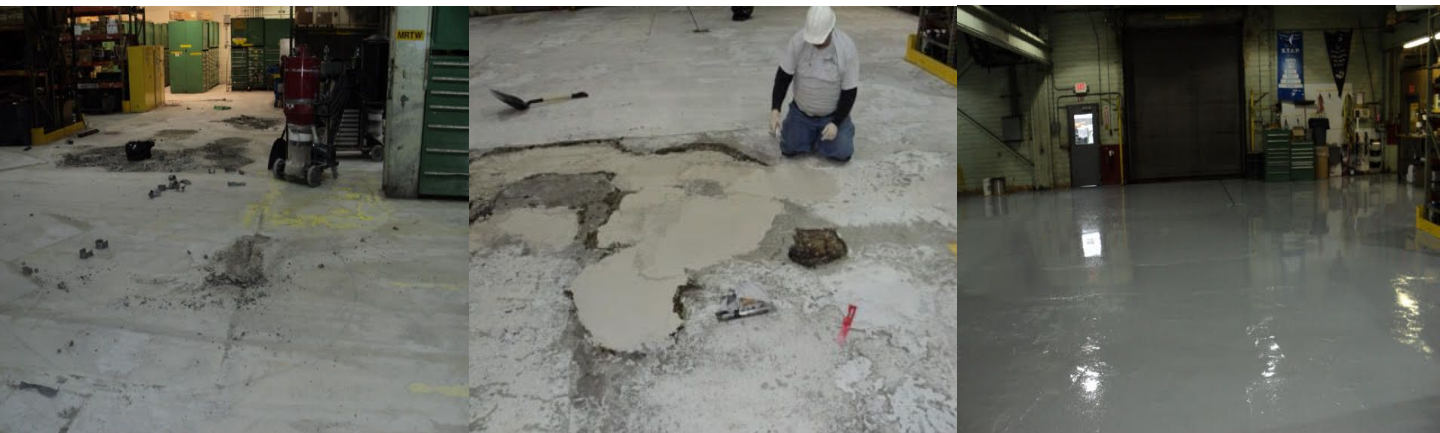
Years of heavy use, forklift traffic water, and cleaning chemicals and salts had severely damaged this floor at the primary warehouse of a Michigan power plant.

[RESICHEM 576 Quartz Screed](#) was used to repair the damage concrete as deep as three to six inches. Then **RESICHEM 506 ALUPRIME** was applied, followed by [USI High Build Epoxy Coat](#), a high-build epoxy coating with excellent abrasion, impact, and chemical resistance.

**USI LD Grip Tech** was also applied for additional safety
