Project: Power Plant Warehouse Floor Restoration

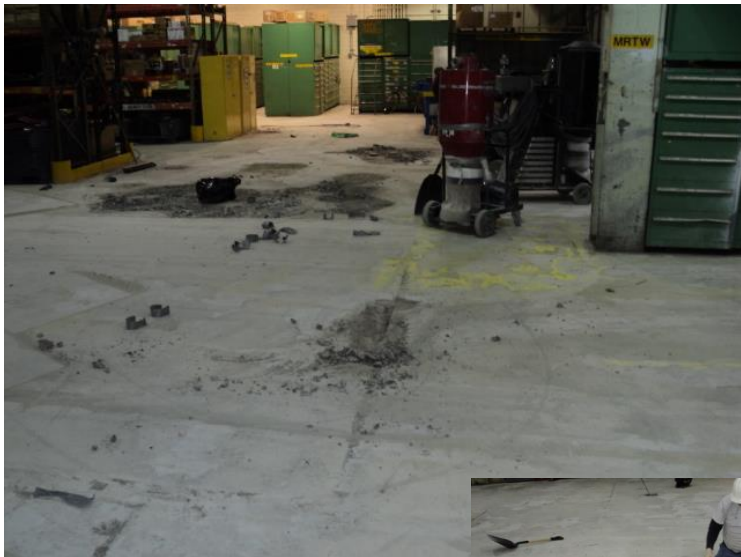
Years of heavy use, forklift traffic, water, and cleaning chemicals and salts had severely damaged this floor at the primary warehouse of a Michigan power plant.

USI Quartz Screed was used to repair damaged concrete as deep as three to six inches. Then **USI Epoxy Primer SP** was applied, followed by **USI Epoxy Floor Coating HB**, a high-build, epoxy coating, with excellent abrasion, impact and chemical resistance.

USI Grip-Tech was applied for added safety.
