## **Project: Concrete Flooring Repair in a Chemical Plant**

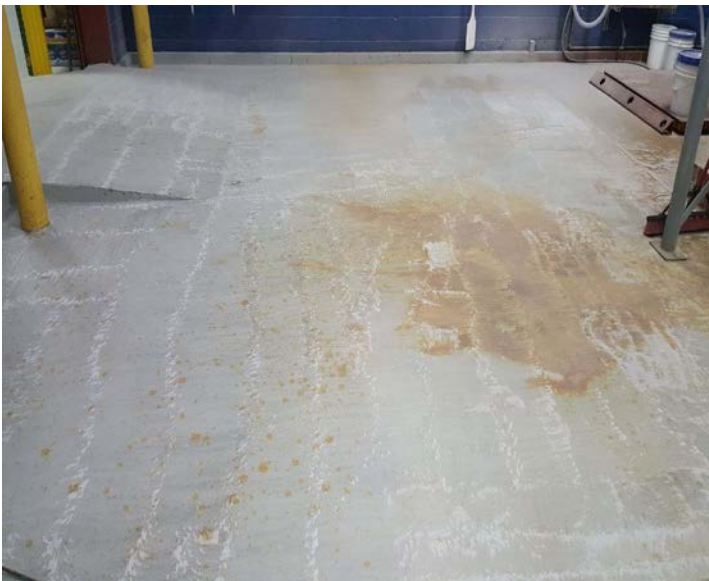
A chemical plant was seeing aggressive chemical attack on their floor. The customer had a cocktail of different chemicals that could be present at any one given moment so they needed a durable multipurpose solution that could provide a long-term solution. After gathering all of the data of the different chemicals USI suggested a system that suited the client's needs.

The most important step of the project was to use a shot blaster with a vacuum on the back to pick up all the contaminated old debris. The first step was to apply **USI Epoxy Primer** to the surface. After that we applied (2) coats of **USI Novolac Floor Coating**.
