## Project: Break Room Floor Refurbishment

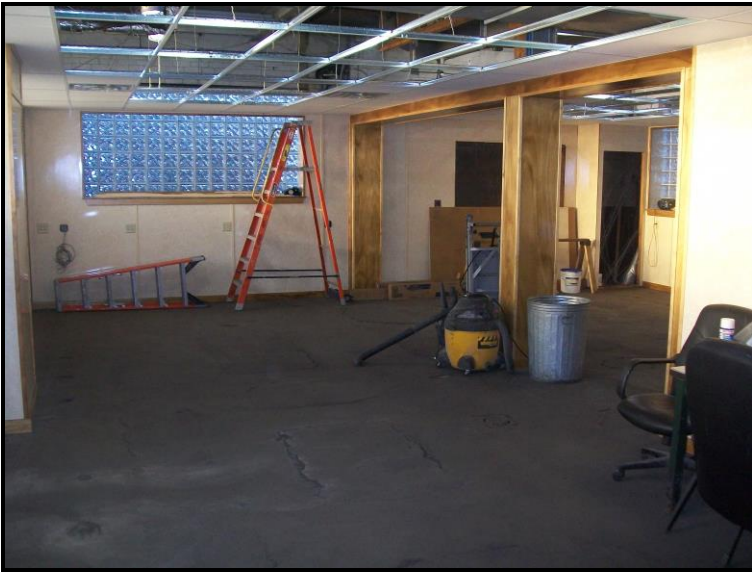
The break room at this prominent steel company was in dire need of refurbishment. The decay happening to the floor was a safety hazard and it was unsanitary.

The floor was first prepared to the correct industry standards; cracks were filled in with **3M Scotchkote Screed RS 820**, and then coated with the **USI Eco Floor WB** system to ensure maximum safety, but also protection to the floor.

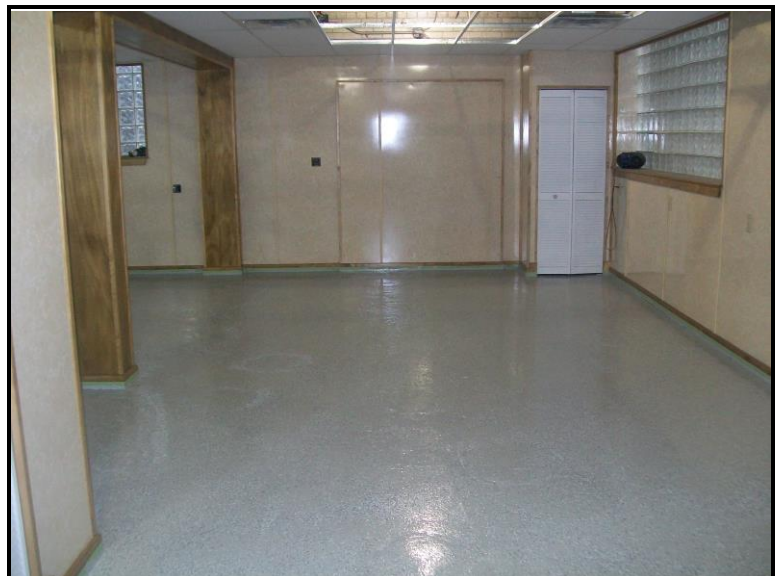
The company loved the clean finish to the floor and the safety it provided to its staff.
