Project: Break Room Floor

The Problem

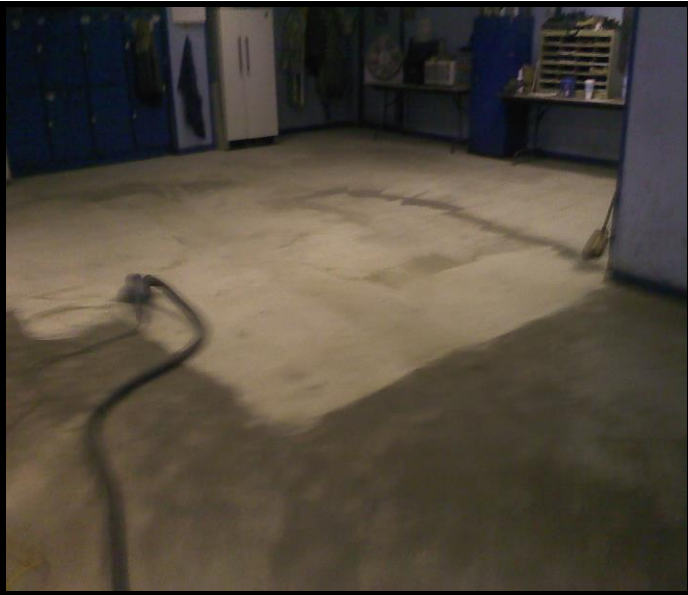
The break room floor at this steel company was damaged from every day wear and tear. The concrete floor in this 800 sq. ft room was beginning to crack, creating a hazardous environment for the employees and the company.

Unconventional Solutions was called to find an alternative to replacing the entire floor. USI recommended using **USI Floor-Tech HB** combined with **USI Floor-Tech SP Primer**.
