## Project: Cylinder Rod Repair

### The Problem

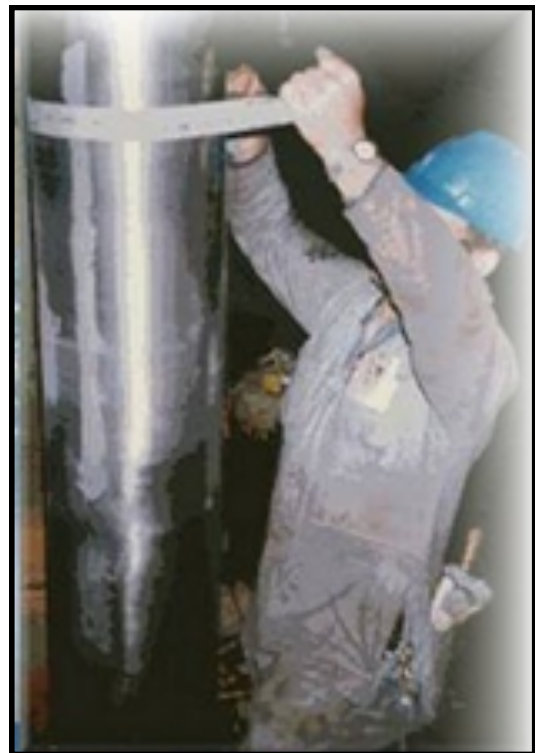
The cylinder rods on an automotive assembly line hoist were scored and pitted causing loss of hydraulic oil, efficiency, and a general mess.

The area was degreased with **USI Universal Cleaner** and the rods were heated to “sweat” out any absorbed oil. After another cleaning with **USI Universal Cleaner**, a series of holes were drilled along the score marks to add surface area for proper adhesion.

**USI Metal Repair EG** was applied, and a profile template was used to remove excess material. After curing, the original profile was restored with wet emery paper. The entire repair process was completed in six hours and was ready for production the following Monday, resulting in no downtime and significant savings over a complete cylinder replacement. The repaired cylinders were still in use 3+ years later.
