Steel Mill Elevator Shaft

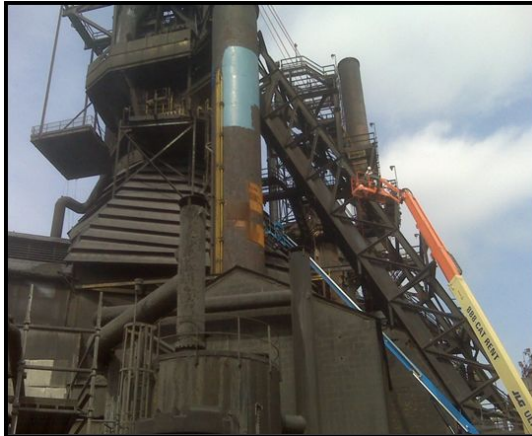
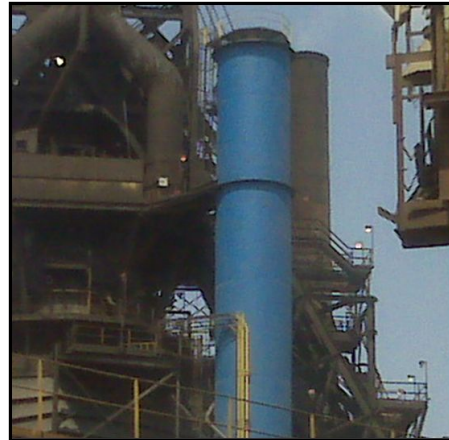
A steel mill in Michigan was experiencing heavy corrosion issues in the elevator shaft of one of their blast furnaces.

The elevator shaft was coated with RESICHEM 555 Resinox. RESICHEM 555 Resinox is a single component, water-based, anti-corrosive acrylic coating which offers superior elastomeric properties. It is simple, easy-to-use, and requires minimal time between applications.

The elevator shaft was wire brush prepped with a surface profile to provide excellent adhesion. One coat of RESICHEM 555 Resinox was applied, by brush, to a DFT of 14 mils.

The elevator shaft has been given a face lift and superior corrosion protection. The steel mill chose RESICHEM 555 Resinox for its ease of use and its superior performance as both a maintenance coating, and a labor cost savings.
