Project: Shaft Repair 2

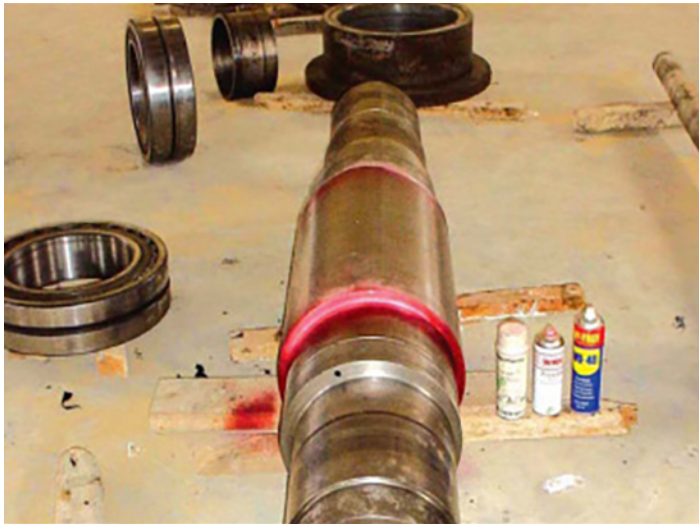
This photograph shows the shaft of a Single Toggle Jaw Crusher located in a mining facility. The bearings of the shaft weighing 3,000 pounds and costing over \$20,000 new had been exposed as a result of this aggressive working environment and many years of use. Four areas of heavy wear were identified for refurbishment. The client required a high-performance engineering repair solution.

The worn sections were suitably prepared to create a rough surface profile, ensuring any loose material and surface contaminants had been removed with **USI Universal Cleaner**. **USI Engineering Metal Repair** was then used to affect a long-lasting repair to the shaft. After a minimum cure time of 2 hours, the shaft was machined back to its original diameter and force cured at 212F for 24 hours using heating pads prior to re-installation.
