## Project: Stainless Steel Conveyor Repair Dearborn, Michigan

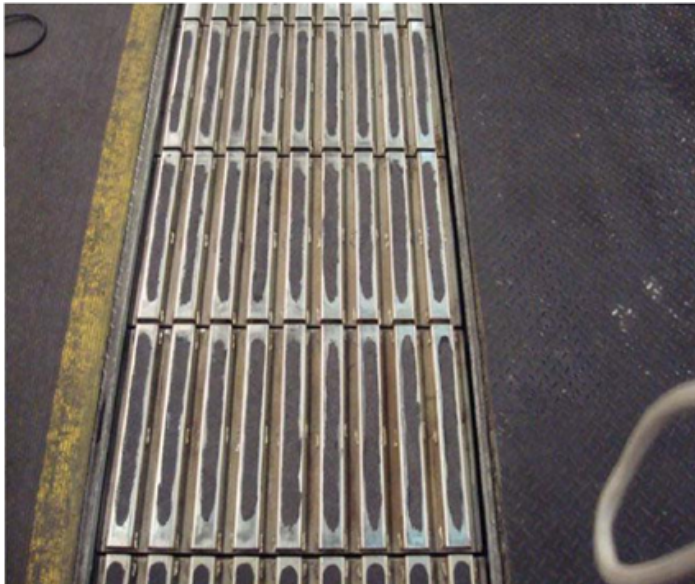
This Stainless Steel Flat Top Conveyor in a local Auto Plant was constantly getting wet causing a major slip hazard to the assembly drivers.

The Conveyor was first cleaned with **USI Universal Cleaner**. To have the coating adhere to the stainless steel, the **MBX Bristle Blaster** was used. The USI Technical Consultant then chose to use **USI 100% Solids Surface Tolerant Epoxy**, followed by **USI Safety Grip System** to offer the assembly plant a long term solution over the conventional safety tape. This gave it a 10 15 times longer life than construction safety tapes and is now stocked in their general supply.
